Petrographic Investigation of Concrete Cores Extracted from Aprons at the Billings Logan International Airport Located in Billings, Montana

Montana State University Bozeman, Montana

Prepared by Chunyu Qiao, Ph.D.

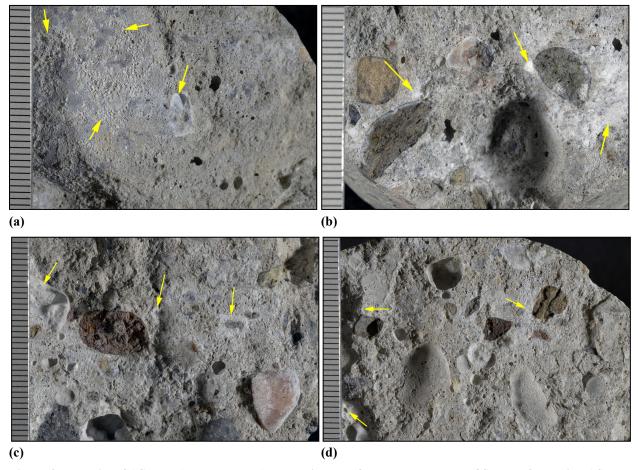
Figure 3. Deposits of ASR gel (yellow arrows) on received surfaces. Photographs of Sample 2 showing ASR gel (a) on the fracture surface and (b) on the bottom surface of the core. Photographs of Sample 5 showing detail of ASR gel on the bottom surface of the core. The scale in each photograph is in millimeters.

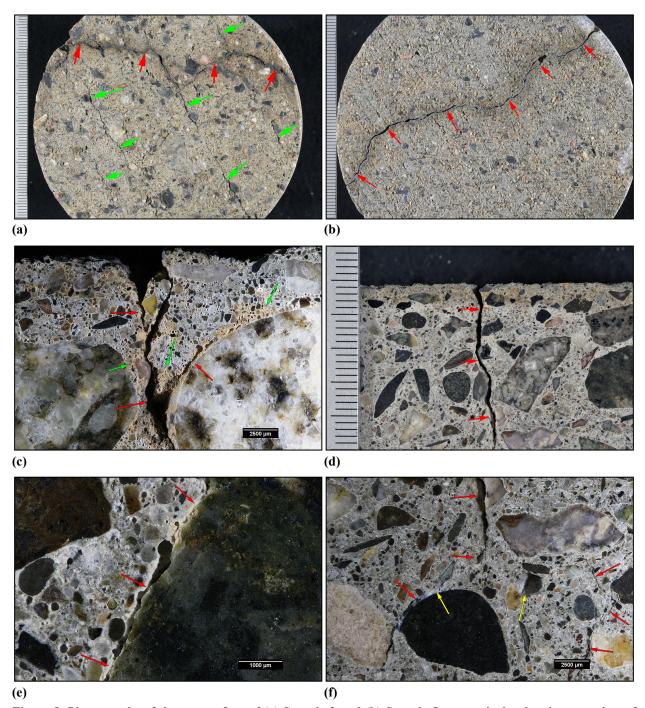
Early age shrinkage cracking Linear cracks were observed cutting sub-vertically from the top surface to depths that reach 25 mm (1 in.) in both cores. These cracks range up to 750 μ m (30 mil) wide; they mainly cut around aggregate particles and are mostly free of secondary deposits. Paste discoloration was also observed along the cracks in Sample 2 due to carbonation, which indicates the long presence of the crack. These linear cracks are likely due to drying shrinkage cracking. The early age cracks facilitate the moisture immigration and the occurrence of ASR, which is indicated by the minor deposits of ASR gel at the bottom end of the cracks. **Figure 8** shows examples of shrinkage cracks.

Figure 8. Photographs of the top surface of (a) Sample 2 and (b) Sample 5, respectively, showing overview of linear orthogonal cracks (red/green arrows) on the top of the core; scale in millimeters. (c) Photograph of the polished surface of Sample 2 showing the sub-vertical cracks (red arrows) near the top of the core. The green arrows indicate paste discoloration due to carbonation. (d) Reflected light photomicrograph of the polished surface of Sample 5 showing the sub-vertical cracks (red arrows) near the top of the core. Photographs of (e)-(f) Reflected light photomicrograph of the polished surface of (e) Sample 2 and (f) Sample 5 showing the bottom end of the cracks (red arrows) filled with ASR gel (yellow arrows).

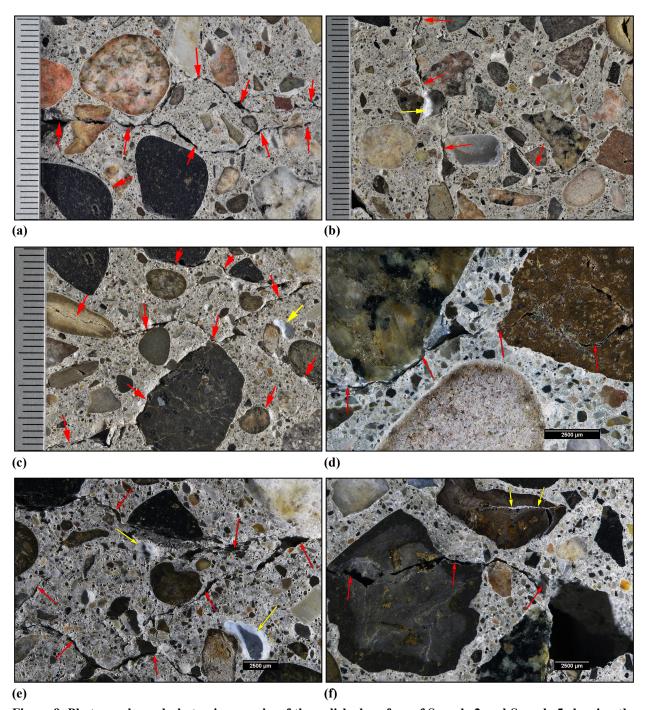
Freeze-thaw cracking Both cores show multiple sub-horizontal cracks throughout the entire depth of the cores. These cracks range up to 1 mm (40 mil) wide and commonly strike across the full width of the polished surface. These cracks mainly cut around aggregate particles and commonly show splays and bifurcations. The cracks are mostly free of secondary deposits but voids along the walls of the cracks commonly contain deposits of ettringite. These properties are consistent with freeze-thaw damage. Sample 2 shows more severe freeze-thaw damage than Sample 5. Occasionally the cracks cut through aggregate particles and contain minor deposits of ASR gel. **Figure 9** shows examples of typical freeze-thaw cracks in both cores.

Figure 9. Photographs and photomicrographs of the polished surface of Sample 2 and Sample 5 showing the sub-horizontal cracks (red arrows). (a), (c) and (e): Sample2. (b), (d) and (f): Sample 5. The yellow arrow indicate deposits of ASR gel. The scale in (a)-(c) is in millimeters.

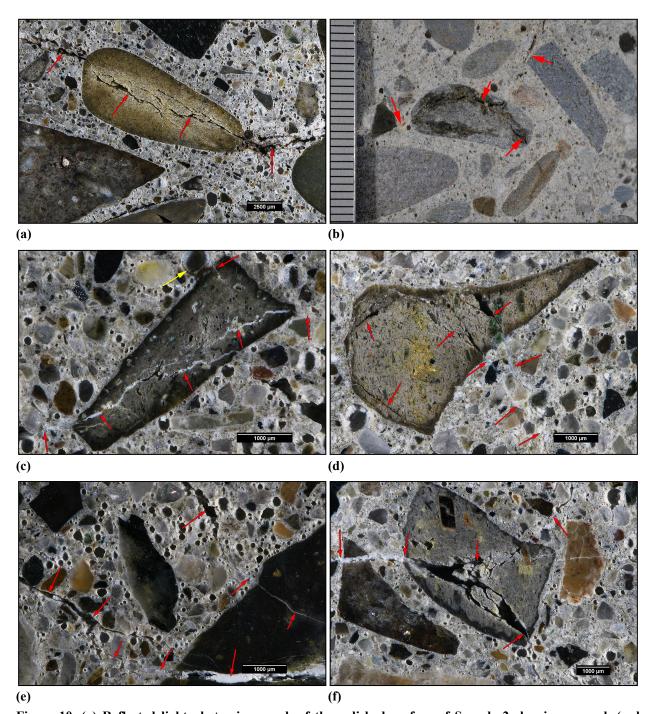
Alkali-silica reaction cracking Both cores show evidence of pattern cracking and microcracking due to ASR. The cracking and microcracking is present through the full length of both cores up to 50-55 mm (2 - 2 $\frac{1}{4}$ in.) long and 200 μ m (8 mil) wide. These cracks commonly cut through or radiate from aggregate particles and contain ASR gel. These cracks due to ASR are finer than the sub-horizontal cracks due to freeze-thaw damage and they are commonly terminated by the cracks due to freeze-thaw damage. This indicates ASR damage occurred after the presence of freeze-thaw damage. Microcracks ranging up to 100 μ m (4 mil) wide and 40 mm (1 $\frac{1}{2}$ in.) long were observed in both cores. These microcracks radiate from reactive aggregate particles or cut through aggregate particles. They commonly contain deposits of ASR gel. **Figure 10** shows examples of cracks and microcracks associated with ASR

Figure 10. (a) Reflected light photomicrograph of the polished surface of Sample 2 showing a crack (red arrows) cutting through a rhyolite particle in the middle of the core. (b) Photograph of the side of Sample 5 showing overview of cracks (red arrows) radiating from an aggregate particle; scale in millimeters. (c)-(f) Reflected light photomicrographs of the polished surface of Sample 2 and Sample 5 showing microcracks (red arrows) radiating from and cutting through aggregate particles. (c)&(e): Sample 2. (d)&(f): Sample 5. The aggregate particles in (c), (d) and (f) are rhyolite, while the particle in (e) is andesite.

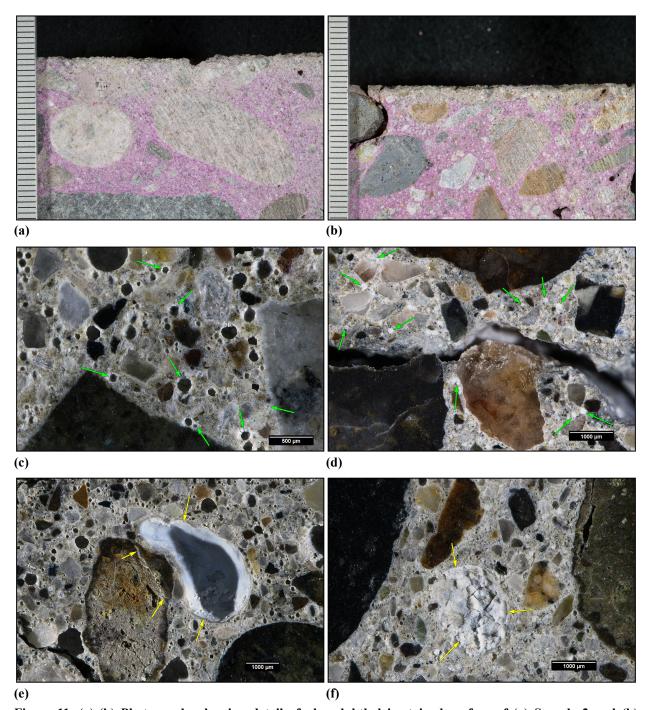
Alkali-Silica Reaction Deposits of ASR gel were observed around aggregate particles, in cracks/microcracks and in voids throughout both cores. The ASR is rated as severe for both cores based on a subjective rating scale developed by DRP. **Table 2** summarizes this scale. The ASR is rated at Stage V using an evaluation scheme described by Katayama et al. [1]. **Table 3** describes this rating scheme. **Figure 11** shows examples of typical reactive aggregate particle in the cores.

Figure 11. (a)-(b) Photographs showing detail of phenolphthalein-stained surface of (a) Sample 2 and (b) Sample 5, respectively, near the top of the cores; scale in millimeters. (c)-(d) Reflected light photomicrographs of the polished surface of Sample 2 and Sample 5, respectively, showing overview of entrained air voids filled with ettringite (green arrows). (e)-(f) Reflected light photomicrographs of the polished surface of Sample 2 and Sample 5, respectively, showing overview of ASR gel (yellow arrows) lining voids in the middle of the cores.

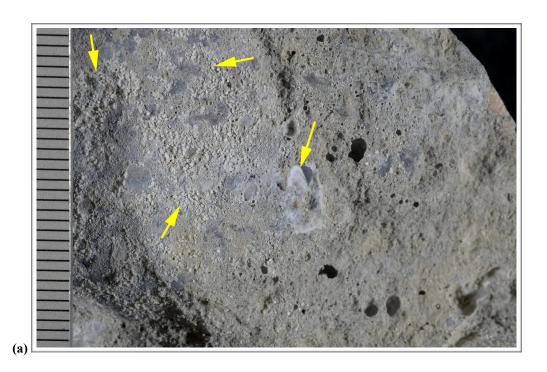
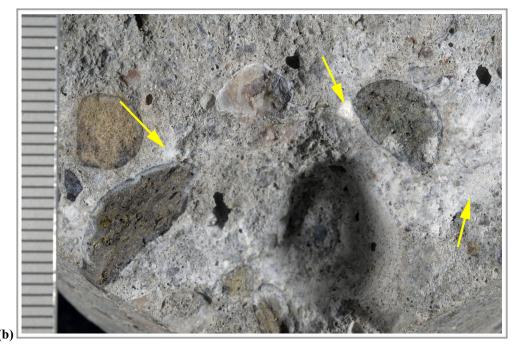
Figure A4. Photographs showing detail of ASR gel (yellow arrows) (a) on the fracture surface and (b) on the bottom surface of the core. The scale in two images is in millimeters.

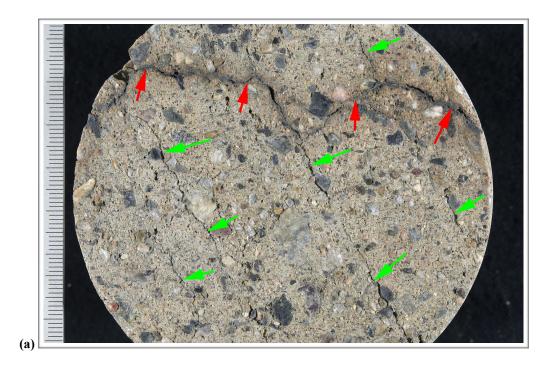
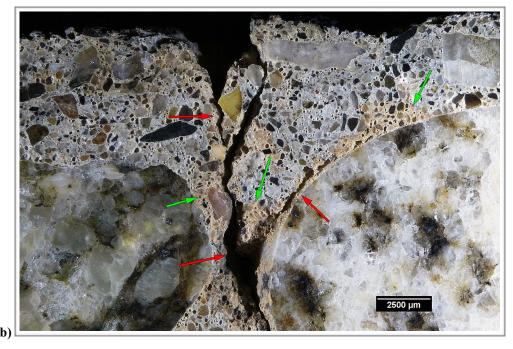
3. CRACKING	
Macroscopic	A linear crack measuring ~ 60 mm (2 3 % in.) long and 200 $-$ 300 µm (8 $-$ 12 mil) wide strike across the top of the core (Figure A5). It cuts sub-vertically to 15 $-$ 25 mm (3 % $-$ 1 in.) from the top of the core, passing mainly around coarse aggregate particles. ASR gel fills the crack at the bottom. Additional parallel cracks were also observed on the top of the core. They measure up to 50 mm (2 in.) long and $100 - 500$ µm (4 $-$ 20 mil) wide. They sub-vertically cut to \sim 30 mm (1 14 4 in.) from the top. They mainly cut around aggregate particles and are partially filled with ASR gel. As described above, a sub-horizontal crack cuts the core in two \sim 120 mm (4 3 4 in.) from the top surface. Multiple additional sub-horizontal cracks were observed throughout the entire depth of the core. They sub-vertically strike across the core. They measure up to 95 mm (3 3 4 in.) long and 1 mm (40 mil) wide and occasionally show splays and bifurcations. The cracks cut through several coarse aggregate particles and are partially filled with ASR gel. Additional relatively fine sub-vertical and sub-horizontal cracks were observed throughout the entire depth of the core. The cracks and microcracks are interconnected and form complex networks of cracking. They measure up to 55 mm (2 14 4 in.) long and up to 200 µm (8 mil) wide. They commonly cut throughout and radiate from aggregate particles and are filled with ASR gel.

Figure A5. (a) Photograph of the top surface showing overview of the major crack (red arrows) and additional parallel cracks (green arrows); scale in millimeters. (b) Reflected light photomicrograph of the polished surface showing overview of the sub-vertical crack (red arrows) at the top of the core. The green arrows in (b) indicate paste discoloration due to carbonation.

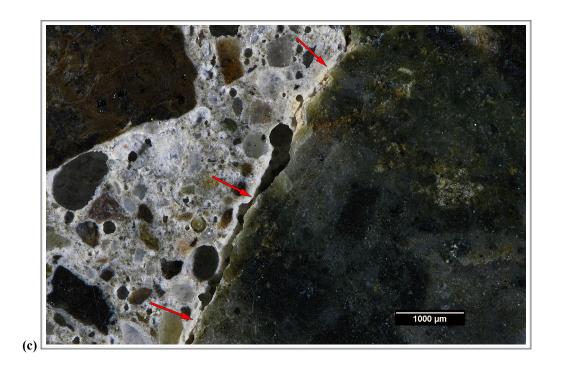
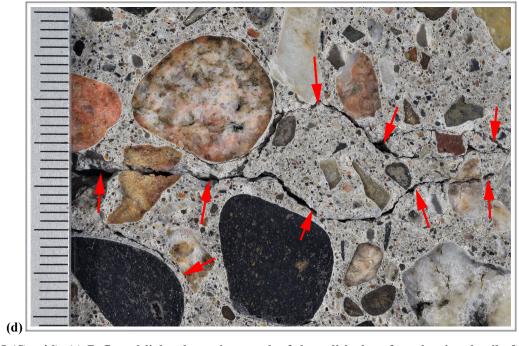
Figure A5 (Cont'd). (c) Reflected light photomicrograph of the polished surface showing detail of the crack (red arrows) with ASR gel at the bottom of the sub-vertical crack in (a). (d) Photograph of the polished surface showing overview of the sub-horizontal cracks (red arrows); scale in millimeters.

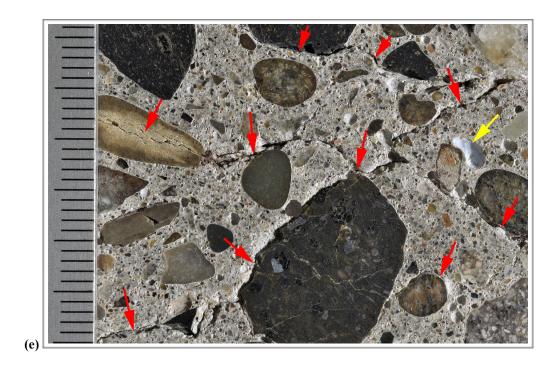
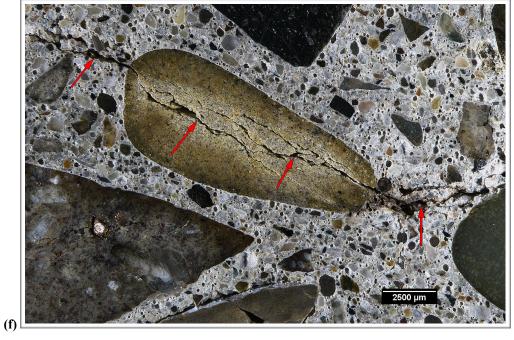
Figure A5 (Cont'd). (e) Photograph of the polished surface showing overview of the sub-horizontal cracks (red arrows); scale in millimeters. The yellow arrow in (e) indicates ASR gel in a void. (f) Reflected light photomicrograph of the polished surface showing overview of cracks (red arrows) cutting through a rhyolite particle. The yellow arrow in (f) indicates ASR gel lining the crack.

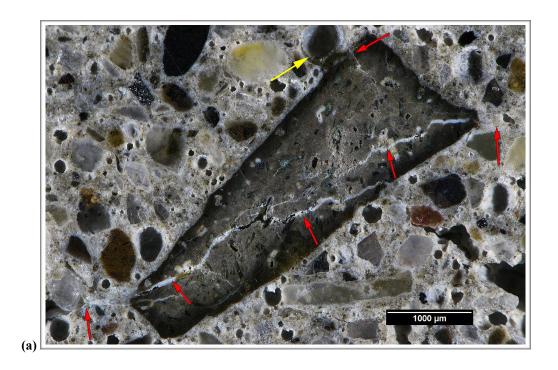
Microscopic	Numerous microcracks were observed throughout the entire core (Figure A6). The microcracks are mainly sub-horizontal in orientation and form an interconnected network. The microcracks measure up to 40 mm (1 $\frac{3}{8}$ in.) long and up to 100 μ m (4 mil) wide. They occasionally to commonly cut through aggregate particles and are filled with ASR gel.

Figure A6. (a) Reflected light photomicrograph of the polished surface showing microcracks (red arrows) cutting through a rhyolite particle and filled with ASR gel. The yellow arrow in (a) indicates ASR gel lining a void. (b) Reflected light photomicrograph of the polished surface showing microcracks (red arrows) cutting through a rhyolite particle and filled with ASR gel. The yellow arrows in (a) indicates ASR gel lining voids and within the rhyolite particle.

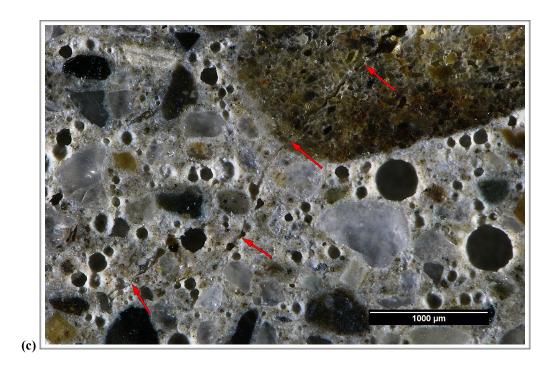
Figure A6 (Cont'd). (c) Reflected light photomicrograph of the polished surface showing microcracks (red arrows) cutting through a quartzite particle. (d) Reflected light photomicrograph of the polished surface showing microcracks (red arrows) cutting through an andesite particle and filled with ASR gel.

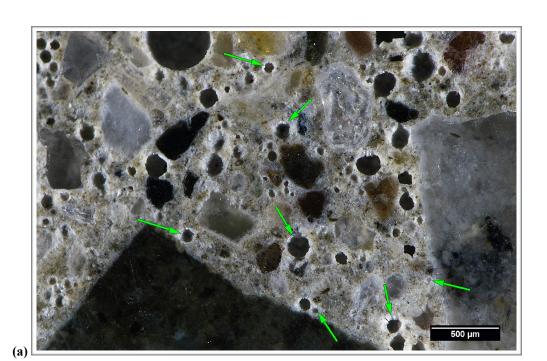
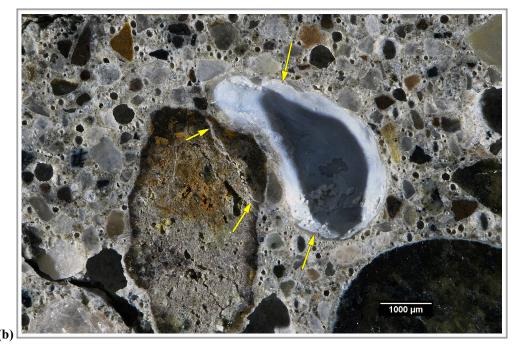
4.VOIDS	
VOID SYSTEM	Concrete is air-entrained and contains $\sim 6\%$ total air as estimated from visual and microscopical observations (not measured in accordance with ASTM C457; Figure A7). Most of the air voids are smaller than 200 μ m (8 mil) across. The concrete is well consolidated.
Void Fillings	Ettringite was commonly observed lining voids throughout the entire core. ASR gel was occasionally observed lining and filling voids throughout the entire core.

Figure A7. Oblique reflected light photomicrographs of the polished surface showing air voids filled with (a) ettringite (green arrows) and (b) ASR gel (yellow arrows) in the middle of the core.

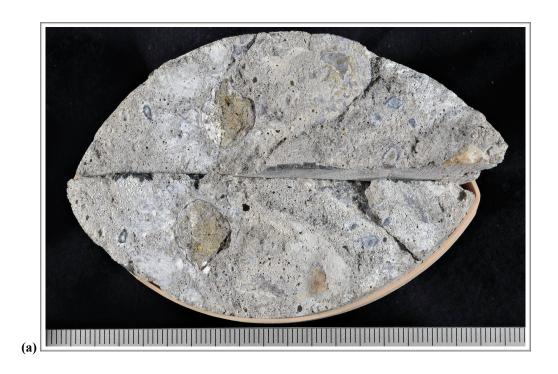
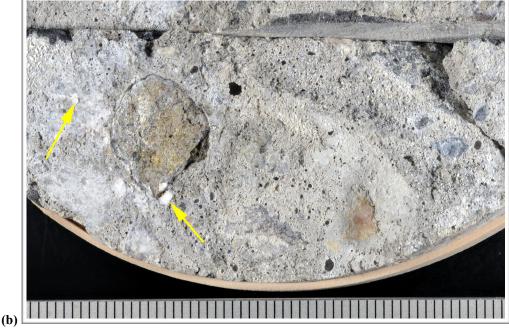
Figure A11. Photographs showing (a) overview and (b) detail of the fresh fracture; scale in millimeters in both images. The yellow arrows in (b) indicate ASR gel on the fracture surface.

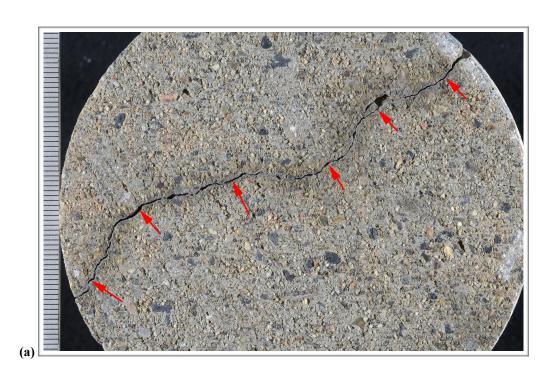
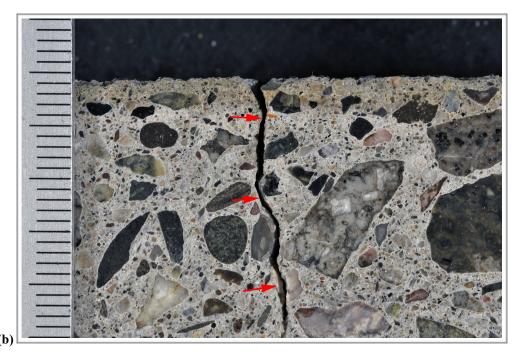
Figure B5. (a) Photograph of the top surface showing overview of the major crack (red arrows); scale in millimeters. (b) Photograph of the polished surface showing overview of the sub-vertical crack (red arrows) at the top of the core; scale in millimeters.

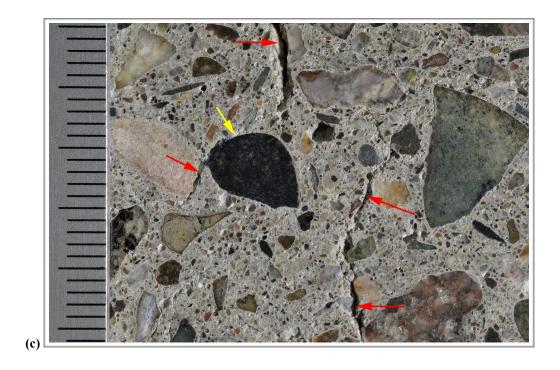
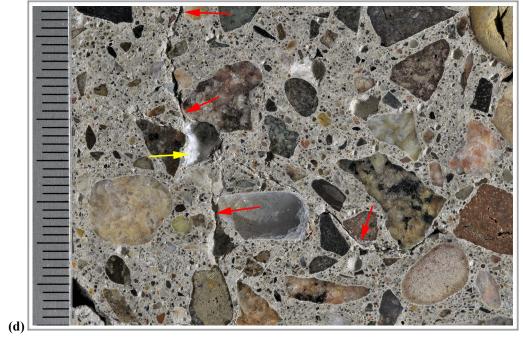
Figure B5 (Cont'd). Photographs of the polished surface showing overview of the sub-vertical and sub-horizontal cracks (red arrows); scale in millimeters. The yellow arrows indicate ASR gel.

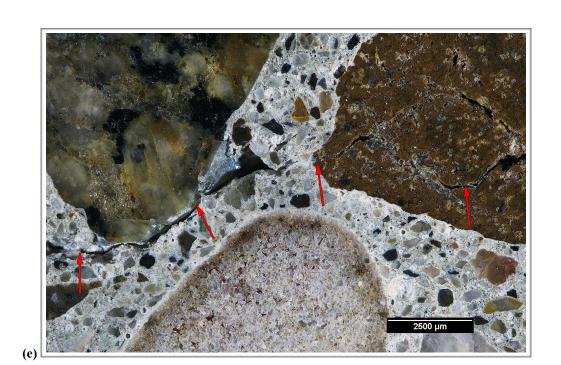
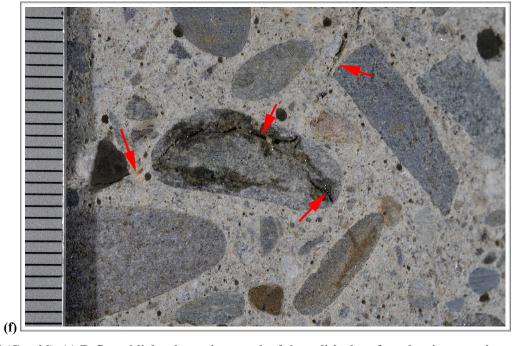
Figure B5 (Cont'd). (e) Reflected light photomicrograph of the polished surface showing overview of the subhorizontal cracks (red arrows) cutting through a rhyolite particle. (f) Photograph of the side of the core showing overview of cracks (red arrows) radiating from an andesite particle. Note ASR gel in the crack in (e).

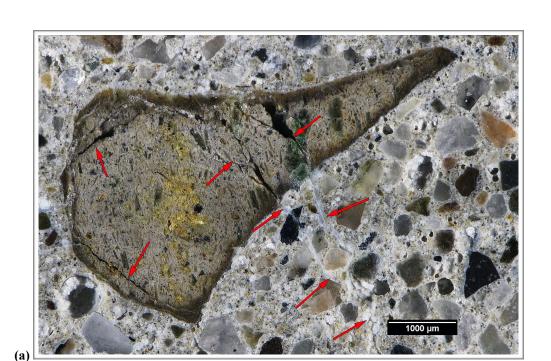
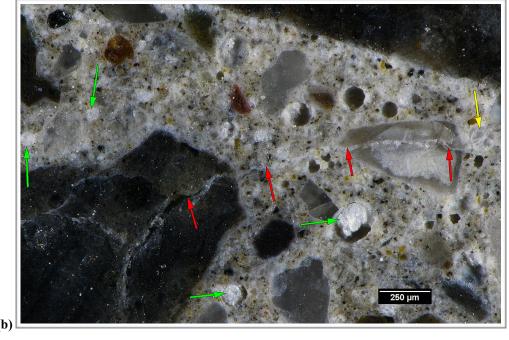
Figure B6. (a) Reflected light photomicrograph of the polished surface showing microcracks (red arrows) cutting through a rhyolite particle and filled with ASR gel. (b) Reflected light photomicrograph of the polished surface showing microcracks (red arrows) cutting through an andesite particle and filled with ASR gel. The yellow arrow in (b) indicates ASR gel lining a void. The green arrows in (b) indicate ettringite.

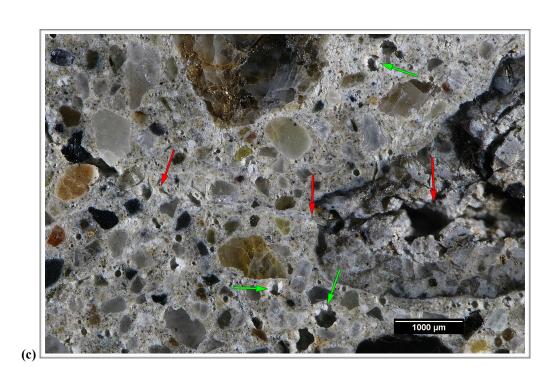
Figure B6 (Cont'd). (c) Reflected light photomicrograph of the polished surface showing microcracks (red arrows) cutting through a rhyolite particle. The green arrows in (c) indicate ettringite. (d) Reflected light photomicrograph of the polished surface showing microcracks (red arrows) radiating from a rhyolite particle and filled with ASR gel.

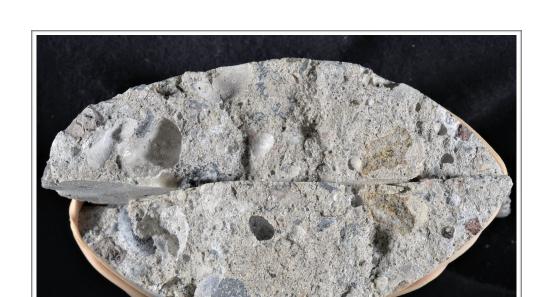
Figure B11. Photographs showing (a) overview and (b) detail of the fresh fracture; scale in millimeters in both images. The yellow arrows in (b) indicate ASR gel on the fracture surface.
